**DEPARTMENT OF TRANSPORTATION**

Contract #: 04-0120F4Cty: SF/ALA Rte: 80 PM: 13.2/13.9File #: 69.28**WELDING INSPECTION REPORT****Resident Engineer:**Pursell, Gary**Address:** 333 Burma Road**City:** Oakland, CA 94607**Report No:** WIR-015975**Date Inspected:** 02-Aug-2010**Project Name:** SAS Superstructure**OSM Arrival Time:** 700**Prime Contractor:** American Bridge/Fluor Enterprises, a JV**OSM Departure Time:** 1900**Contractor:** Zhenhua Port Machinery Company, Ltd (ZPMC), Changxing Island **Location:** Shanghai, China**CWI Name:** Li Yang and Zhu Zhong Hai**CWI Present:** Yes No**Inspected CWI report:** Yes No N/A**Rod Oven in Use:** Yes No N/A**Electrode to specification:** Yes No N/A**Weld Procedures Followed:** Yes No N/A**Qualified Welders:** Yes No N/A**Verified Joint Fit-up:** Yes No N/A**Approved Drawings:** Yes No N/A**Approved WPS:** Yes No N/A**Delayed / Cancelled:** Yes No N/A**Bridge No:** 34-0006**Component:** OBG Trial Assembly**Summary of Items Observed:**

## WELDING INSPECTION REPORT

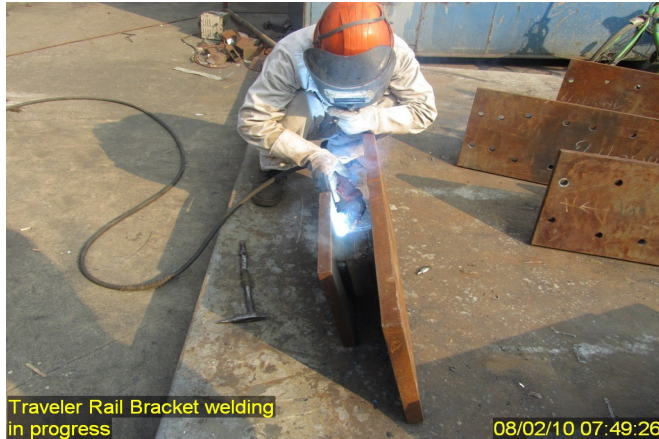
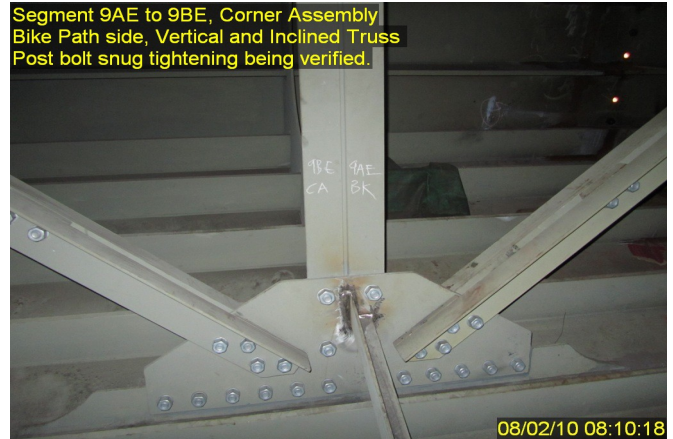
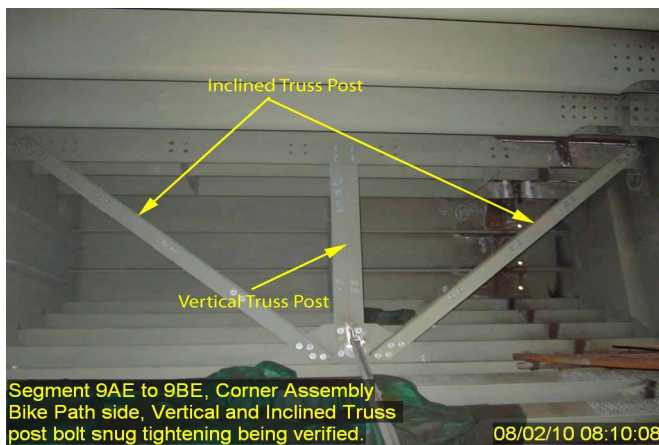
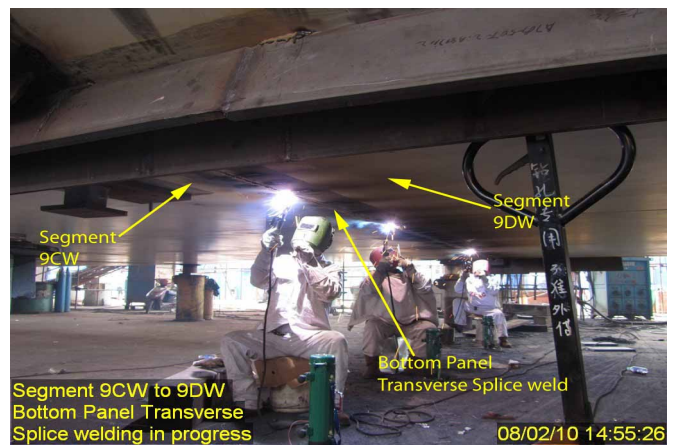
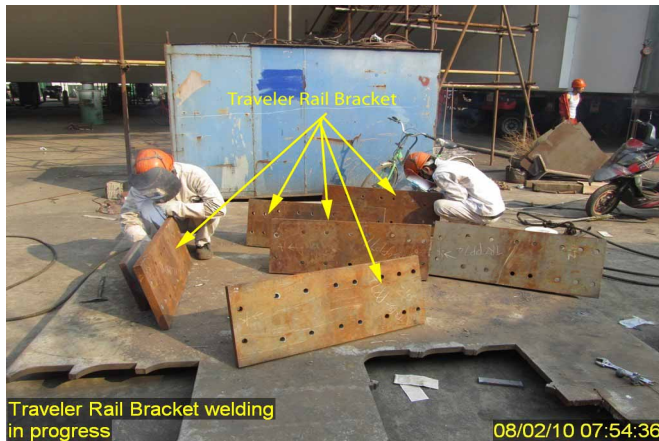
This QA Inspector verified and checked the snug tightening for the bolts installed at Corner Assembly at cross truss post and vertical truss post on random basis along with ZPMC QC Mr. Zhang Hai Jung for Segment 9AE at the Cross Beam and Bike Path side at Panel Points (PP) 72 and PP 73. The QA Inspector observed the results appeared to be in general compliance.

The bolt sizes used were M22 x 85, M22 x 55, M24 x 60, M24 x 65 and M24 x 80. Please reference the pictures attached for more comprehensive details.

the Cross Beam and Bike Path side at Panel Points (PP) 74, PP 75 and PP 76. The QA Inspector observed the results appeared to be in general compliance.

This QA Inspector observed the in process welding by Flux Cored Arc Welding (FCAW) process on a Complete Joint Penetration (CJP) groove weld. The Weld joint was designated as TR6B-PP72-004. The welder identification was 204342 and was observed welding in the 1G (Flat) and 3G (Vertical) position using approved Welding Procedure Specification WPS-B-T-2231-Tc-U4C-F and WPS-B-T-2231-Tc-U4C-F. The piece mark was identified as the Traveler Rail Bracket.

This QA Inspector observed the in-process welding by Shielded Metal Arc Welding (SMAW) process on a Complete Joint Penetration (CJP) groove weld. The Weld joint was designated as OBW9C-003. The welder identification was 067765, 066038 and 067642 and was observed welding in the 4G (Overhead) position using approved Welding Procedure Specification WPS-B-P-2214-B-U2-FCM-1. The piece mark was identified as the Bottom Panel, transverse splice weld. Please reference the pictures attached for more comprehensive details.

This QA Inspector observed the in process welding by Flux Cored Arc Welding (FCAW) process on a Complete Joint Penetration (CJP) groove weld. The Weld joint was designated as TR6B-PP78-004. The welder identification was 222369 and was observed welding in the 1G (Flat) and 3G (Vertical) position using approved Welding Procedure Specification WPS-B-T-2231-Tc-U4C-F and WPS-B-T-2231-Tc-U4C-F. The piece mark was identified as the Traveler Rail Bracket. Please reference the pictures attached for more comprehensive details.
